De Losa **P**roperty **I**nspections

Inspection Report

1234 Sample St.
Phoenix AZ 85044

Date: 10/19/2016	Time: 10:30 AM	Report ID:
Property: 1234 Sample St. Phoenix AZ 85044	Customer: Mr. Valued Customer	Real Estate Professional: Scott De Losa

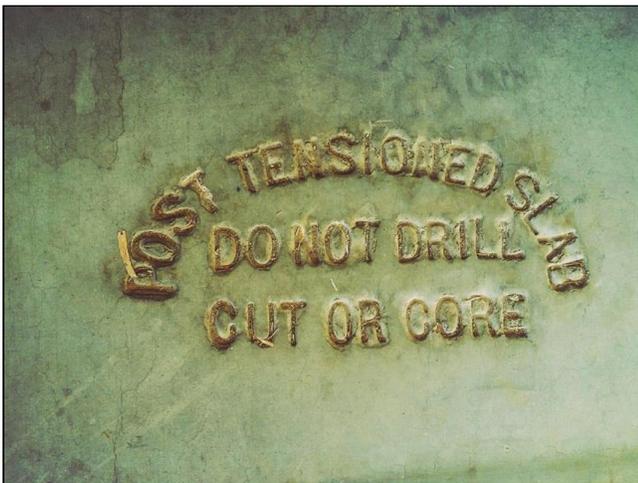
1.0 Item Picture:

FYI: Post-Tension Slab label stamped in garage floor. (DO NOT CUT, CORE or DRILL). Click on link to learn more about: [Post-Tension Slabs](#)

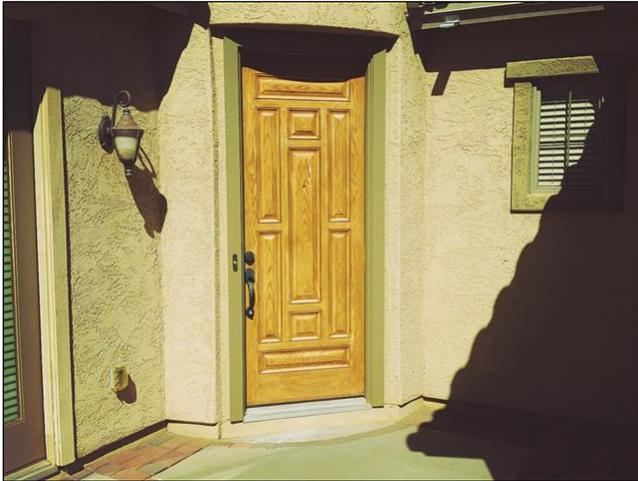
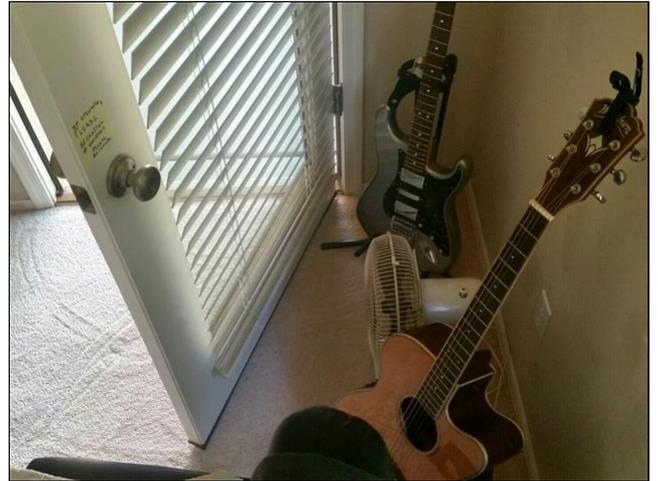
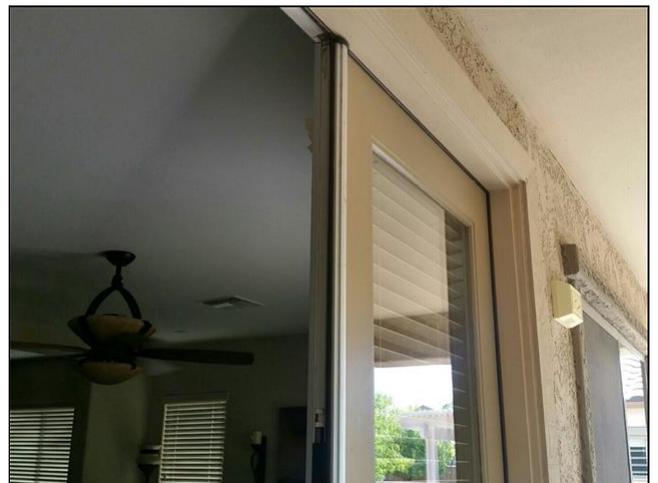
1.4 Item Picture:

Front entry door weathered, missing door stops at master bedroom door and family room french doors.

Upper latch at East french door in family room inoperable.

Minor water damage noted at bottom section of casing/trim at formal dining room french doors.

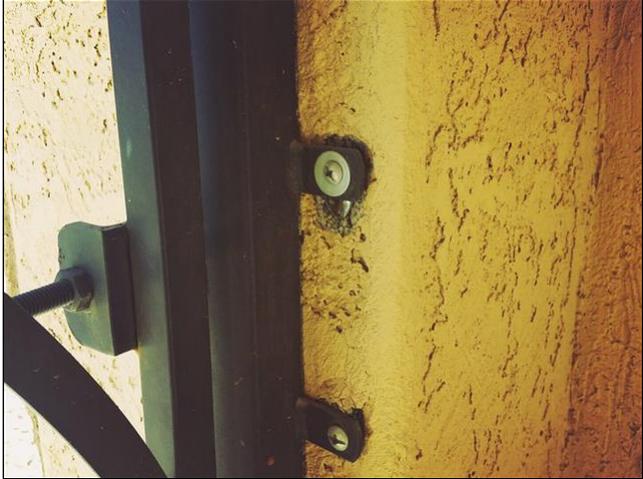
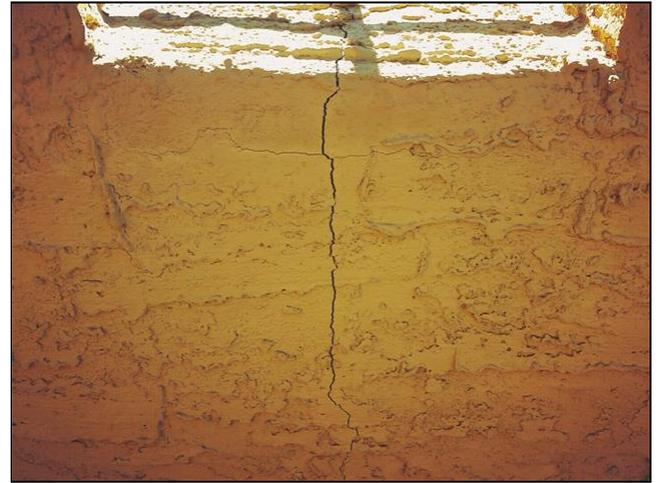
2.1 Item Picture:

FYI: Minor stucco damage and upper West section somewhat loose at front entry gate.

Recommend monitoring drainage performance at N/E section of front patio.

Minor cracks present at front patio block fencing.

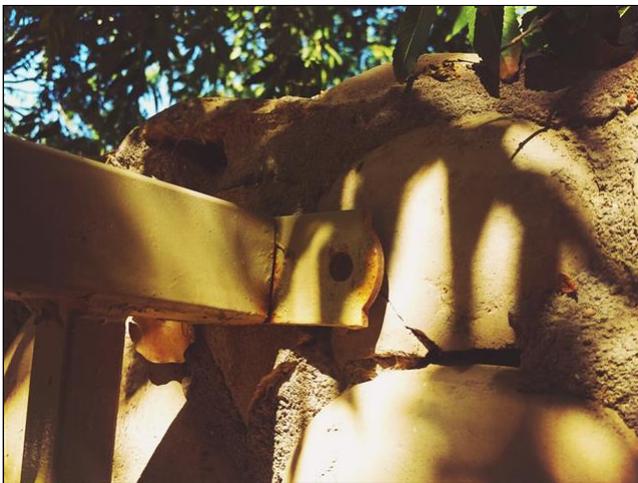
2.1 Item Picture:

Upper S/W section of metal fence not attached properly.

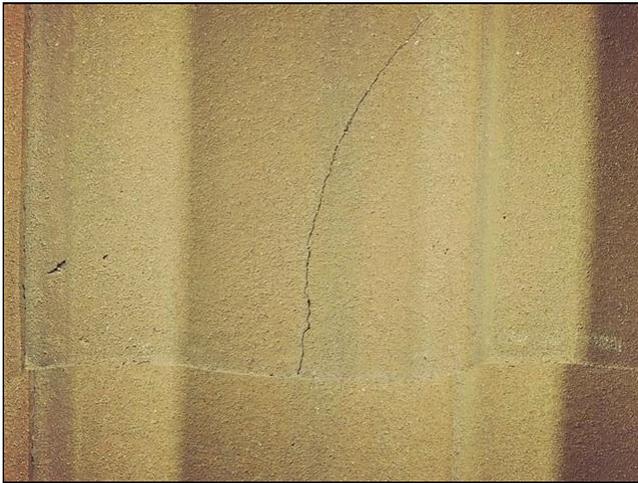
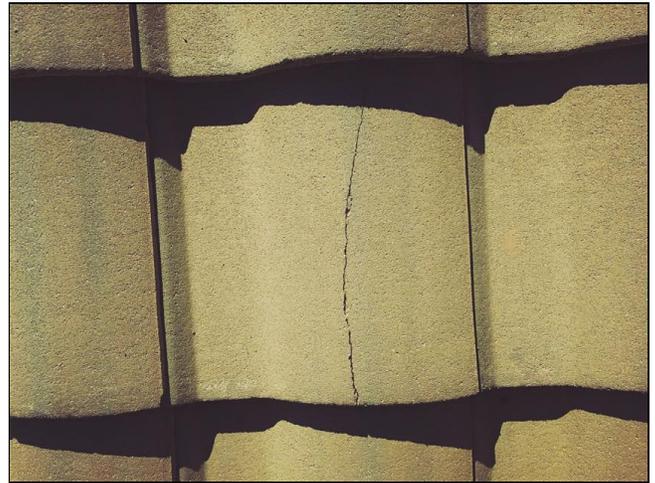
3.1 Item Picture:

Cracked/broken tiles present, one at North section, one at S/W section and one at East section. Repair or replacement recommended.

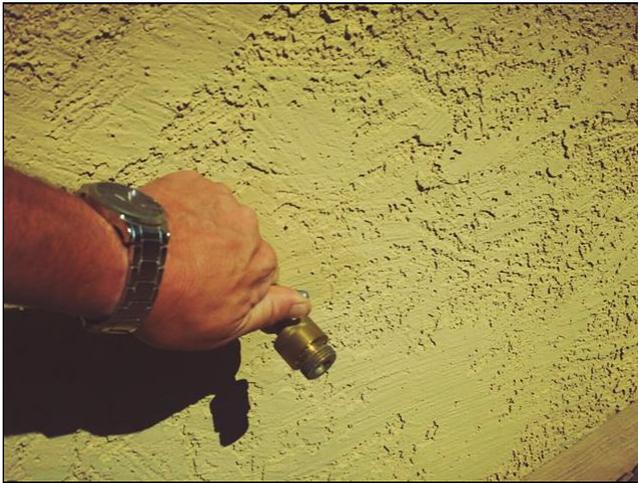
5.1 Item Picture:

S/E hose bib inoperable.

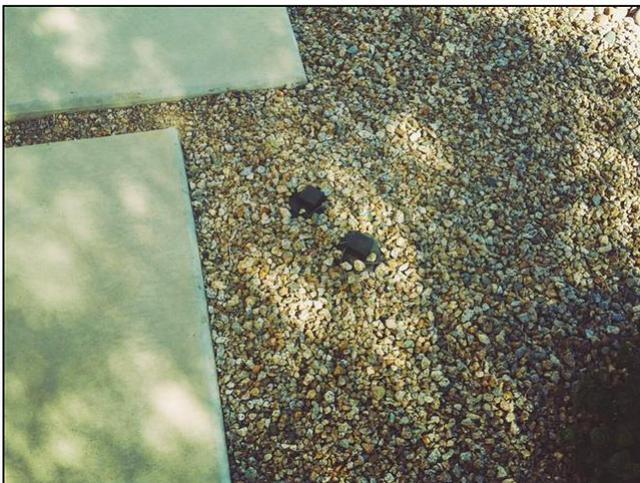
5.2 Item Picture:

FYI: Functional drainage appears Satisfactory: Based on industry recommended water tests, the drain pipes are functional at this time. However, only a video-scan of the main drainpipe could confirm its actual condition.

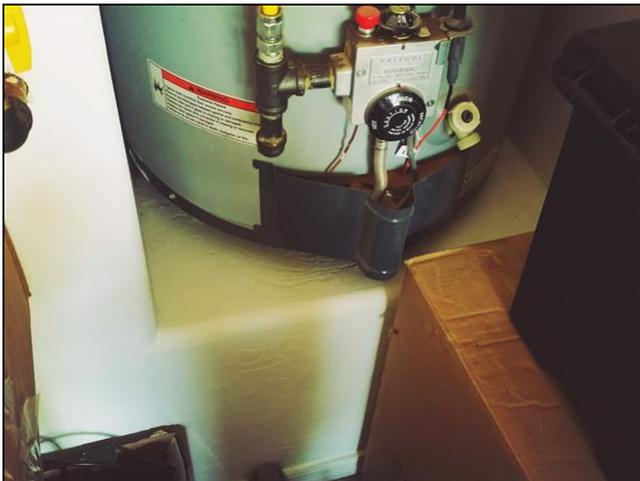
5.4 Item Picture:

FYI: Recommend installing a drain pan under tank with overflow pipe designed to prevent/minimize water damage from a leak.

Drip leg not present at fuel supply line, adjustment and/or monitoring recommended.

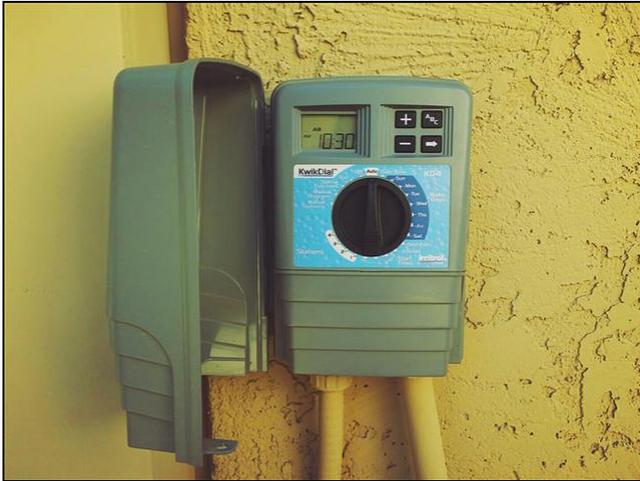
5.5 Item Picture:

Over spray present at back patio areas, recommend adjusting sprinkler heads.

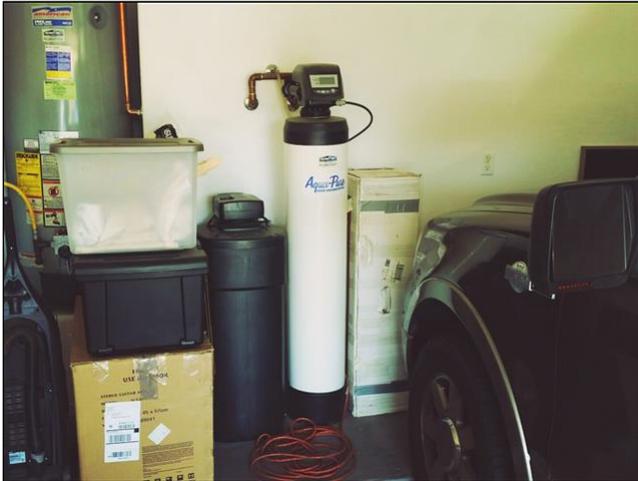
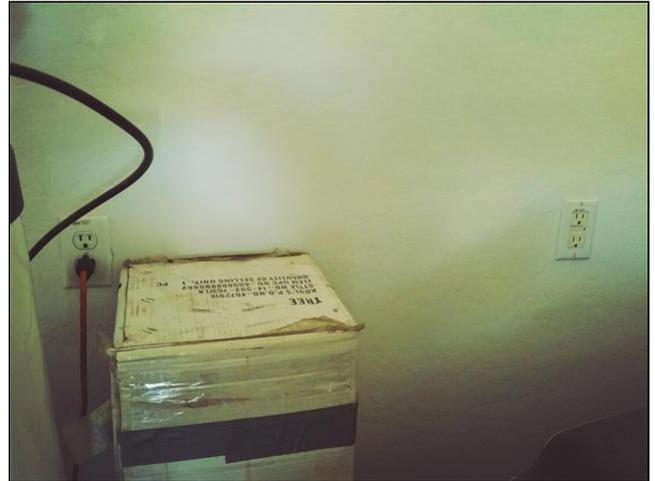
5.6 Item Picture:

FYI: Water softener system present but is not part of a professional home inspection. Recommend further evaluation and corrections as/if needed.

Water softener system plugged in to GFCI protected receptacle(s); therefor if the circuit trips the units(s) may become inoperable.

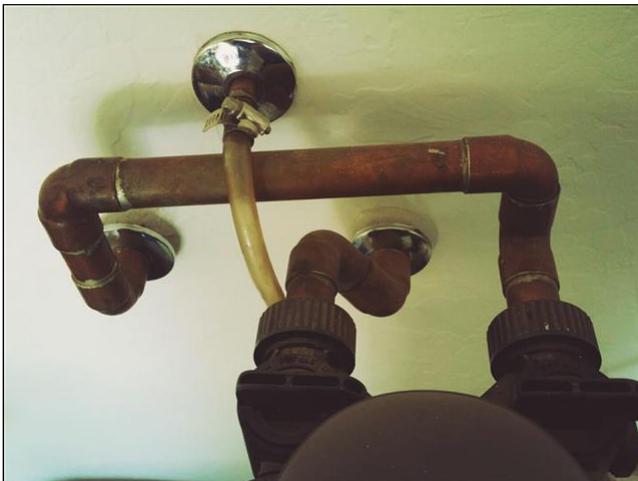
5.6 Item Picture:

Bonding jumper not present at water supply lines.

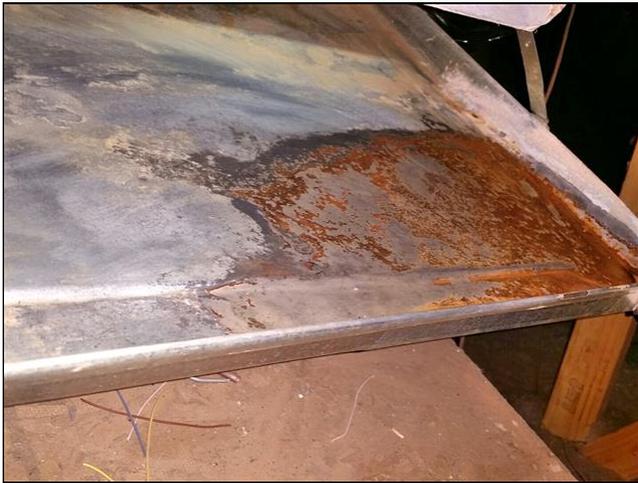
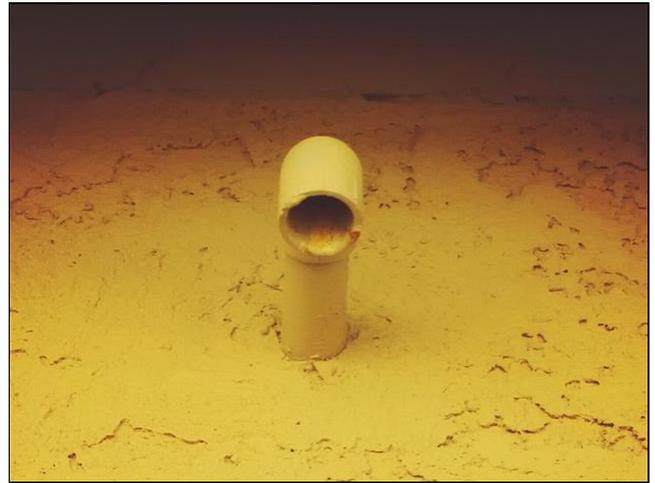
7.3 Item Picture:

Rust noted in secondary pan, exterior secondary extension and stucco finish. Further evaluation recommended.

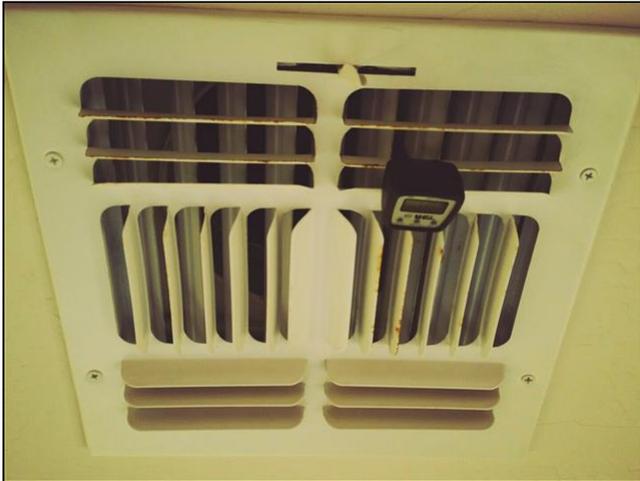
7.6 Item Picture:

FYI: West/center bedroom and hall bath air registers rusting, monitor.

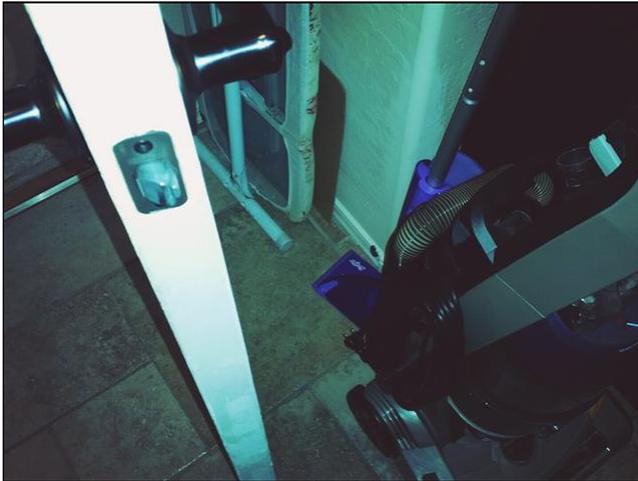
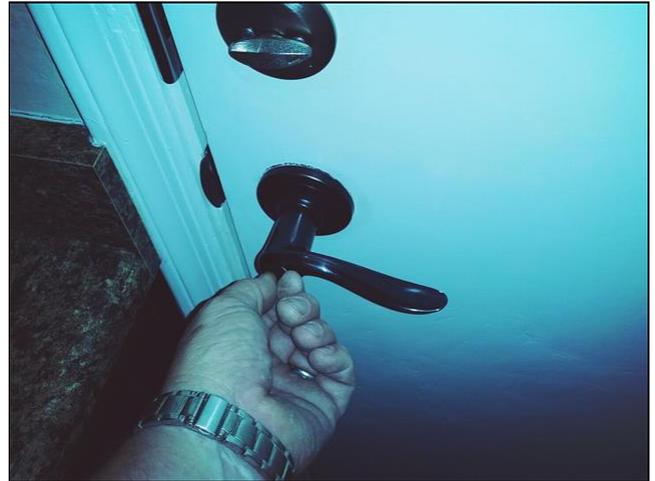
8.1 Item Picture:

Missing door stop and knob did not lock.

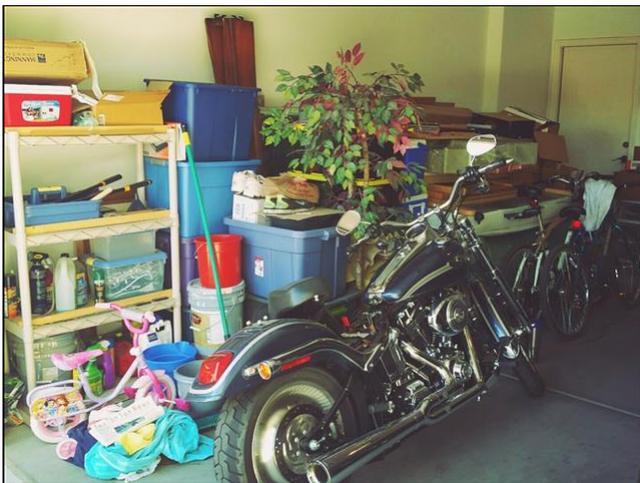
8.3 Item Picture:

FYI: Sections of garage inaccessible due to stored items/personal belongings and/or cabinets. Recommend further inspection when items have been removed.

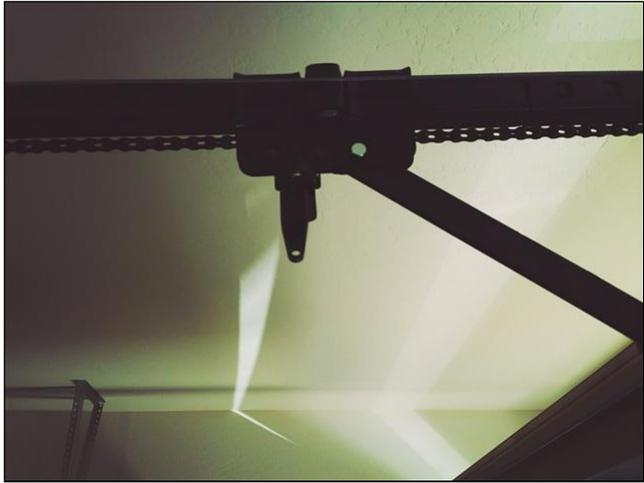
8.6 Item Picture:

Automatic door openers emergency release cord is missing/not attached. Corrective measures should be taken.

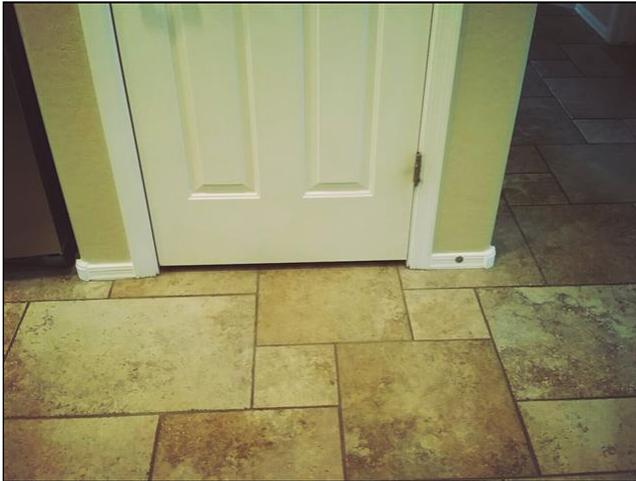
9.1 Item Picture:

Missing door stop at pantry door.

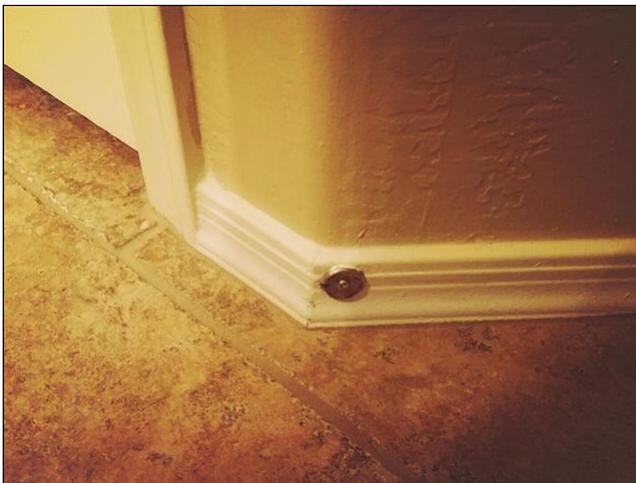
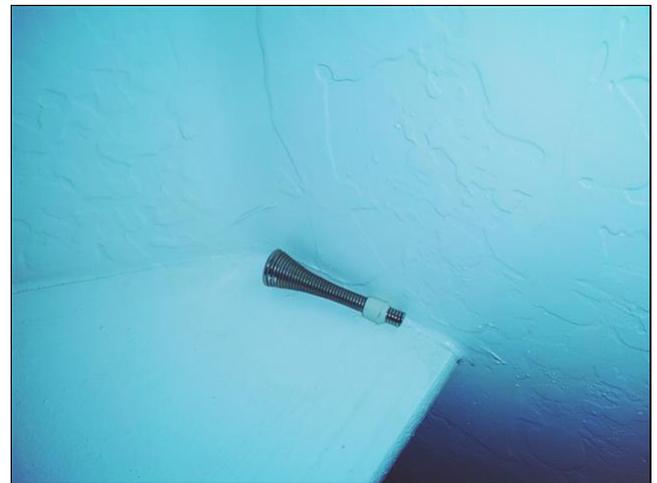
11.1 Item Picture:

Missing door stop at hall bathroom (stopper present in linen closet).

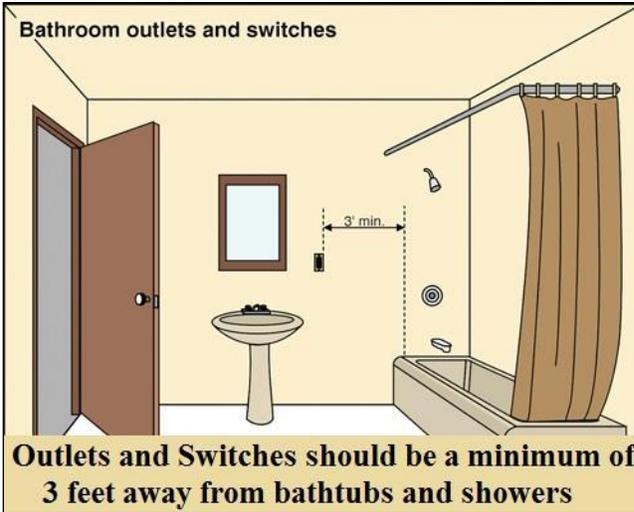
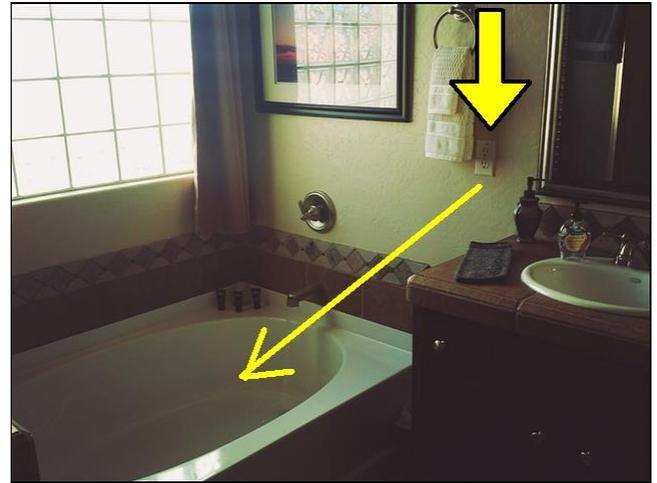
11.2 Item Picture:

Common builder error/flaw: Poorly located receptacle noted. Any outlet closer than 3 feet from tub/shower is potentially dangerous. Recommend moving the receptacle between the two sinks and/or testing the GFCI receptacle regularly to assure proper operation.

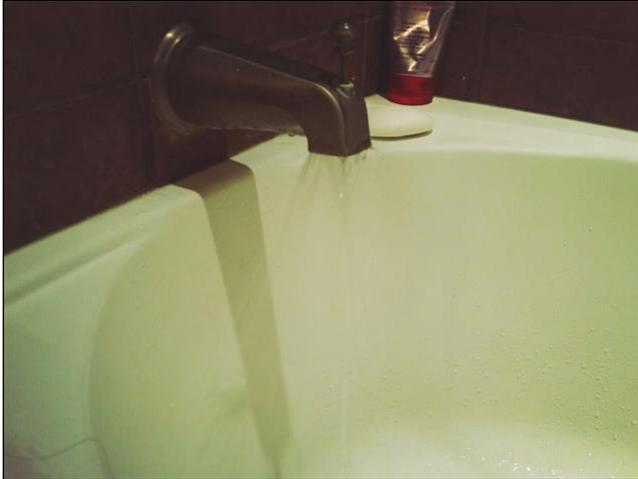
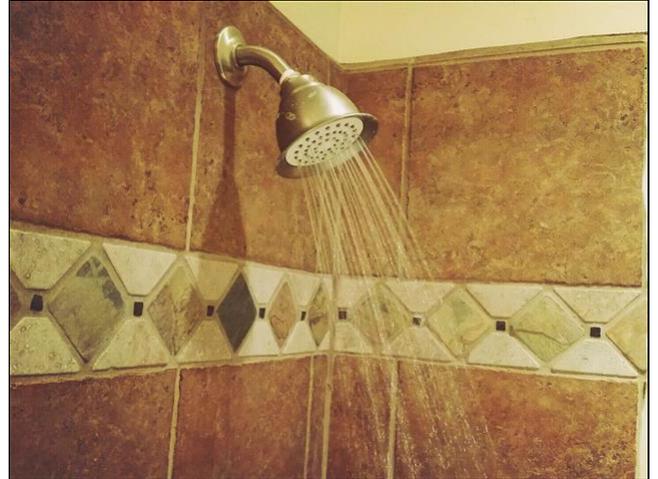
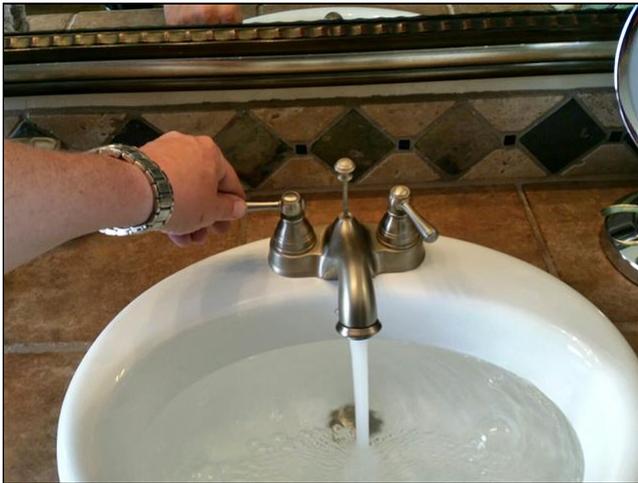
11.4 Item Picture:

Diverter valve at bathtub spout does not fully direct water flow to shower head when engaged: Hall bathtub/shower.

Hot water handle at East faucet in master bathroom somewhat difficult to operate.

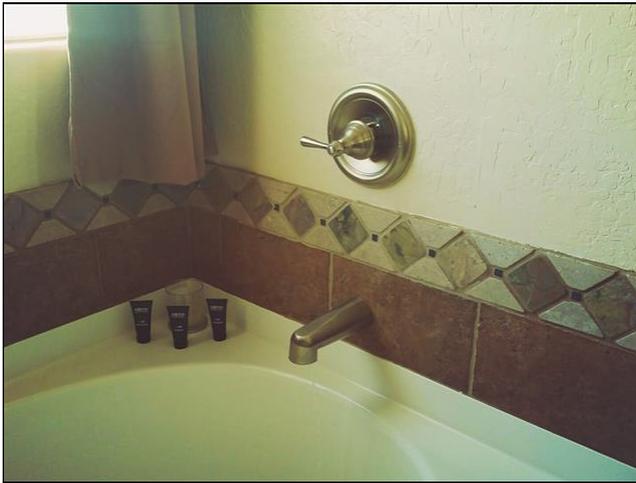
11.4 Item Picture:

Action Item:**Mixing valve at master bathtub inoperable in hot position.**

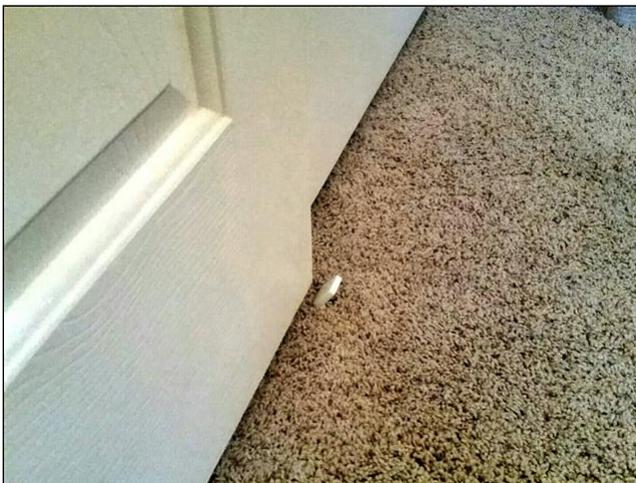
12.1 Item Picture:

Closet floor guide in North bedroom bent/damaged.

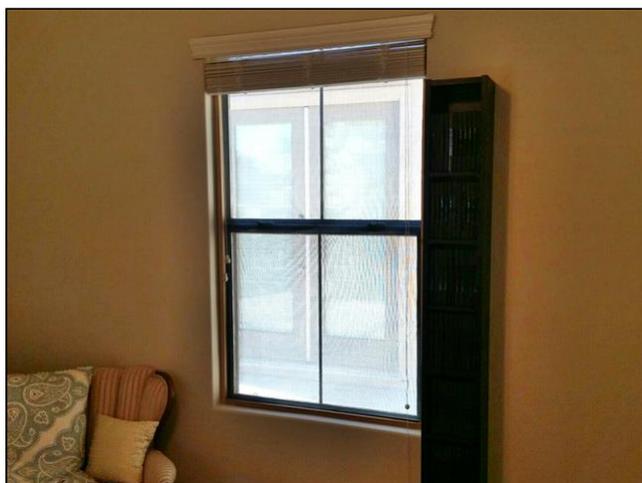
12.2 Item Picture:

FYI: Screen framed in at South window in North bedroom, I did not remove the screen to test window due to risk of damage.

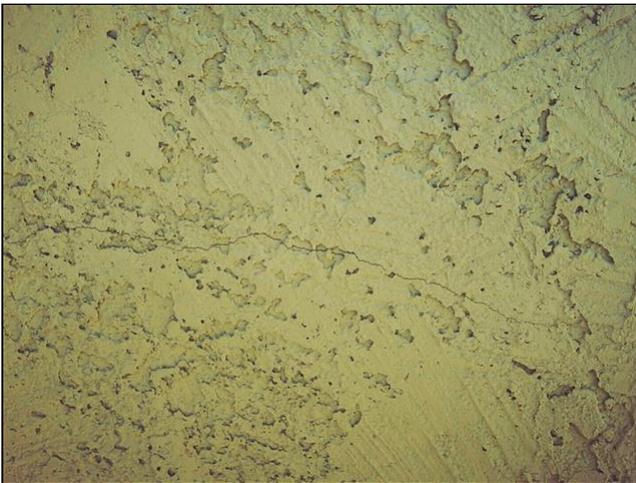
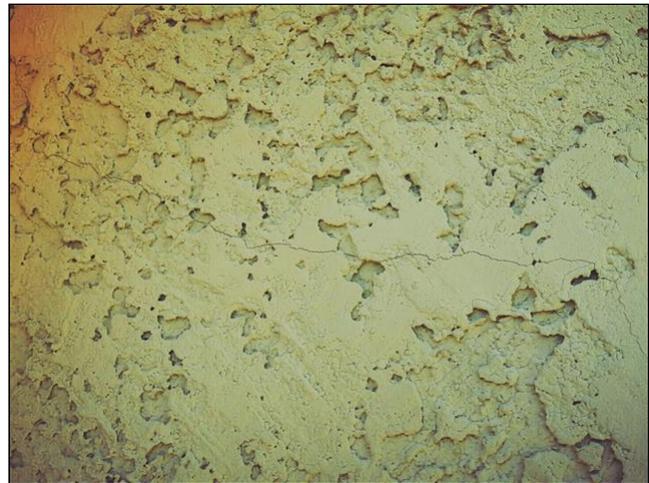
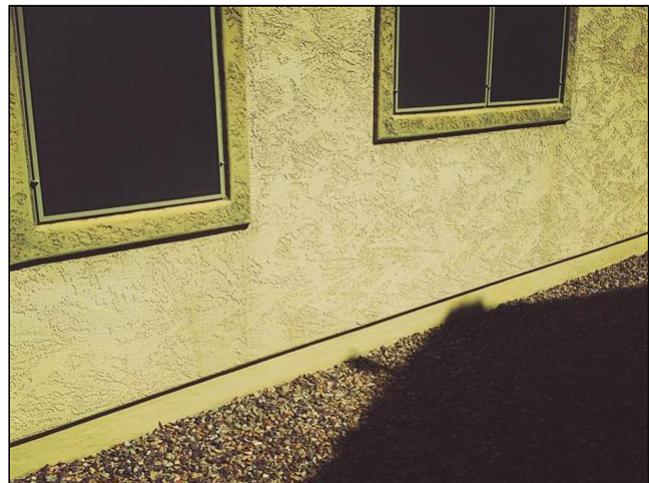
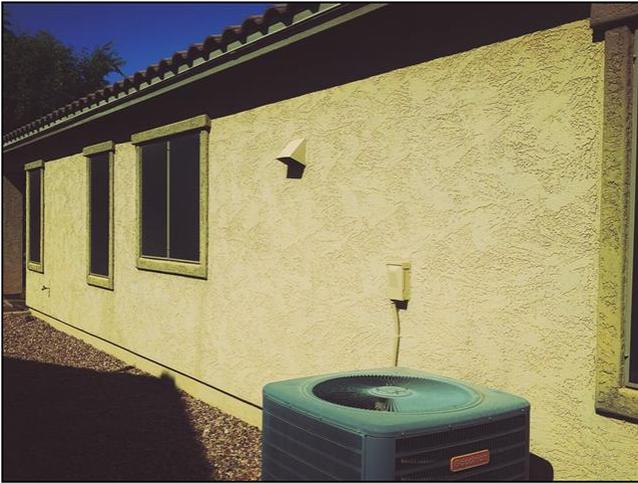
14.0 Item Picture:

Common stucco cracks and/or repairs observed in various areas around perimeter, monitor and patch as necessary.

Paint weathered at East side of home.

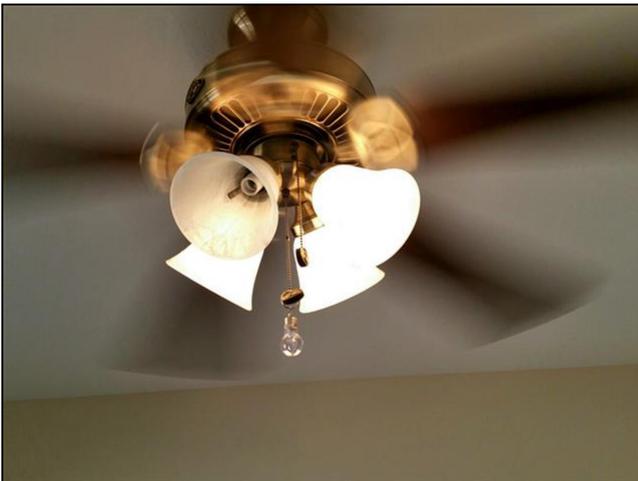
14.1 Item Picture:

S/W bedroom.

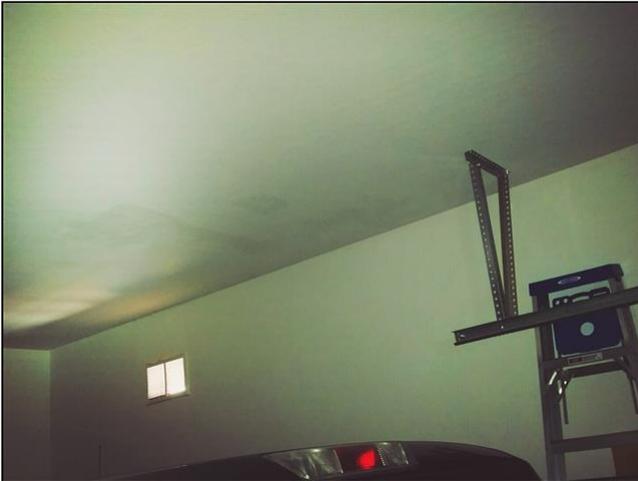
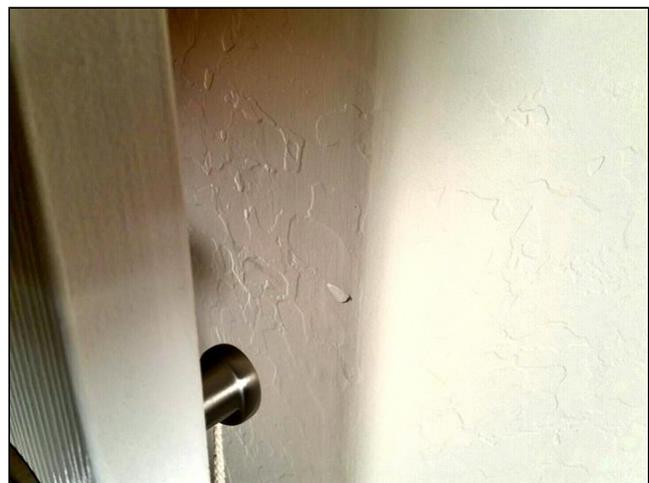
14.2 Item Picture:

Dents and mismatched paint and/or repairs noted in various areas.

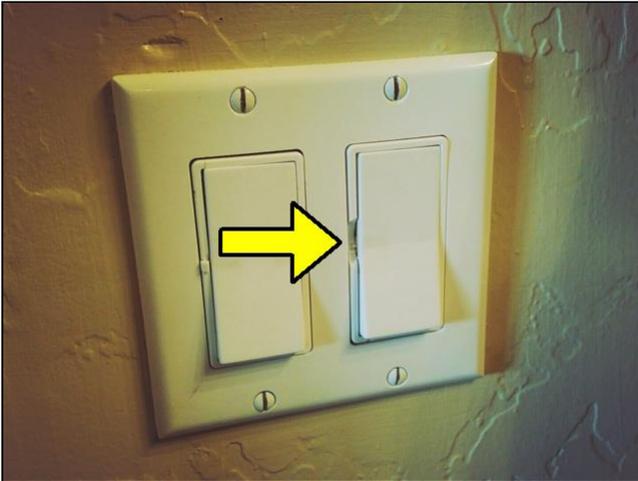
14.3 Item Picture:

Minor damage to hall bathroom light switch/trim.

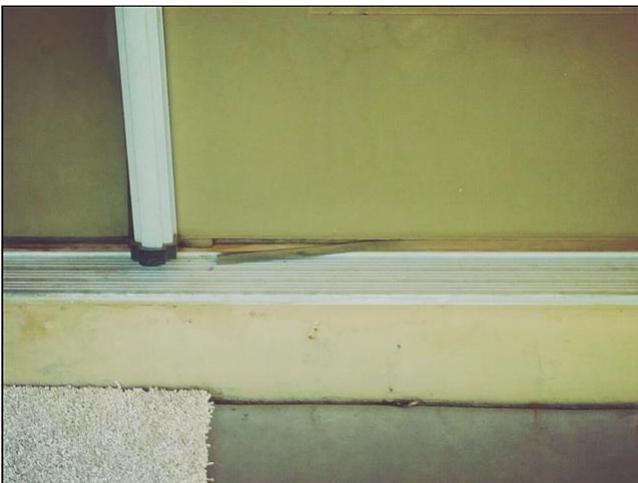
14.4 Item Picture:

Minor impact damage present at upper section of master bedroom door casing/trim and East section of dining room french door casing/trim.

Missing screw cap/cover at garage door threshold.

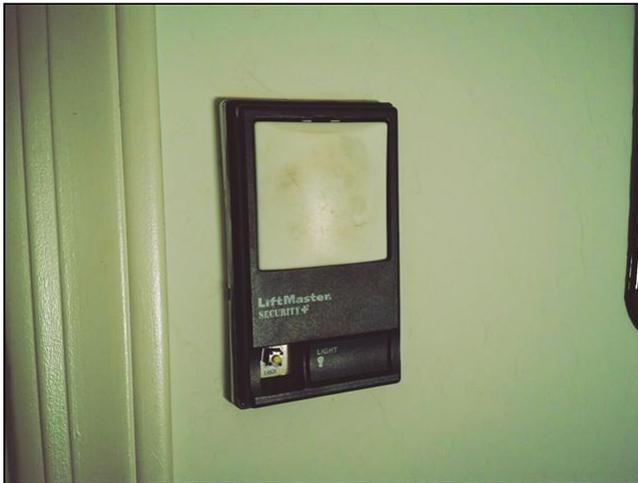
14.5 Item Picture:

Button cover missing on automatic opener mounted on wall, screw not driven in completely at garage side of knob.
