Inspection Report

1100 N. Sample Report St.
Surprise AZ 85374

De Losa Property Inspections

Date: 11/16/2017	Time: 10:00 AM	Report ID: Sample Report 11/17
Property: 1100 N. Sample Report St. Surprise AZ 85374	Customer: Mr. Scott De Losa	Real Estate Professional:

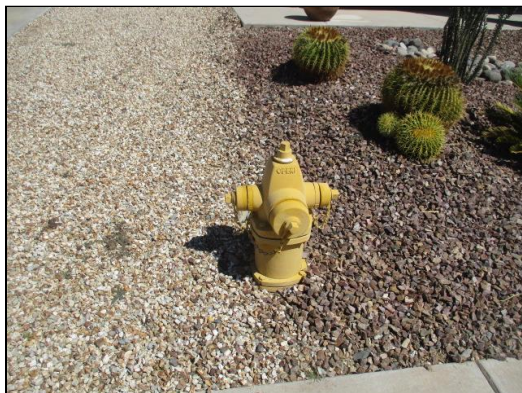
Positive Attributes; Be sure to mention to your insurance company that there is a fire hydrant in close proximity to your home; you may qualify for a discount.

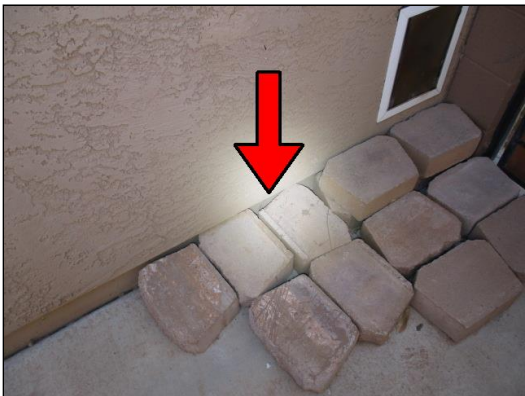
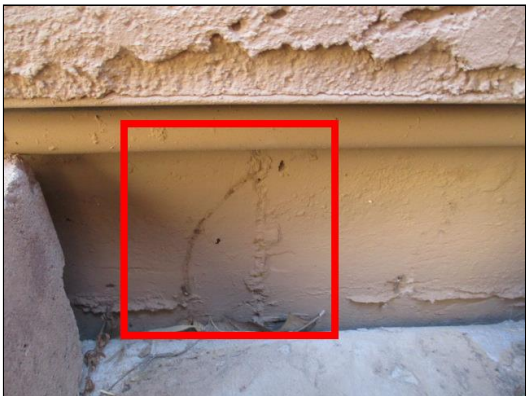
1.0 Item 1(Picture)

Subterranean termite shelter tube stains observed.
Treatment and/or monitoring by a licensed professional advised.

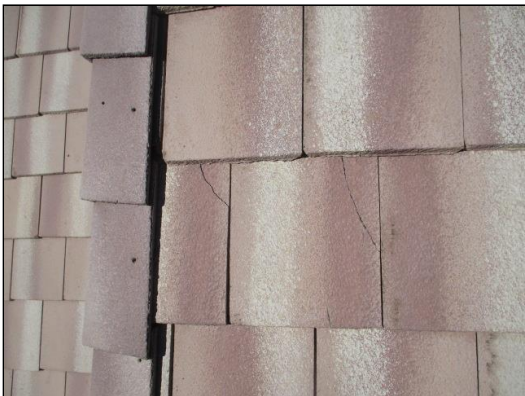
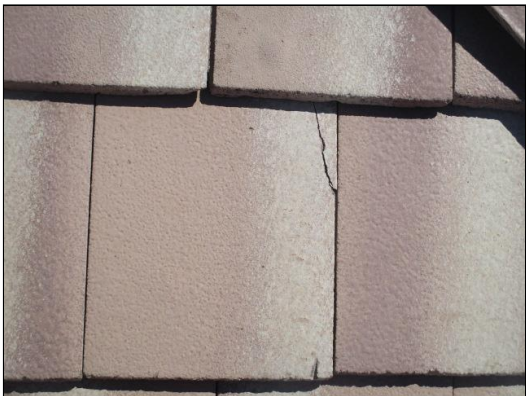
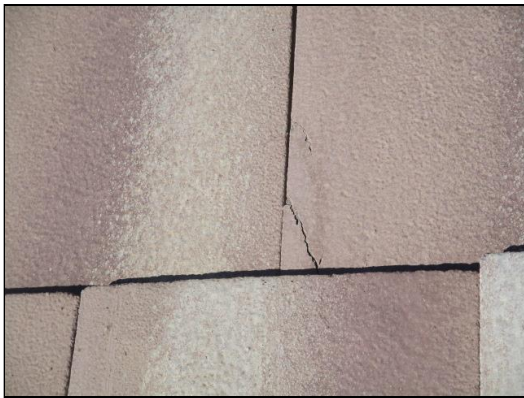
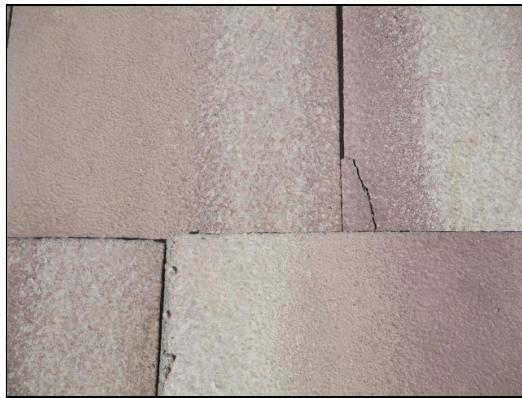
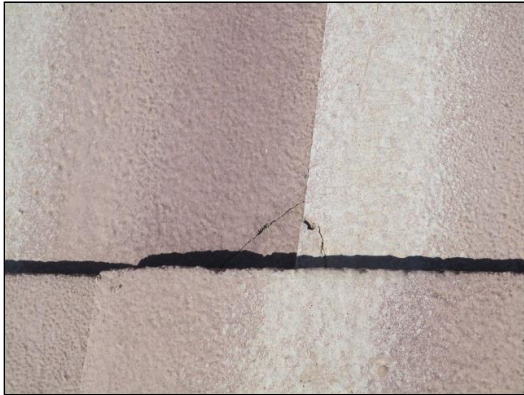
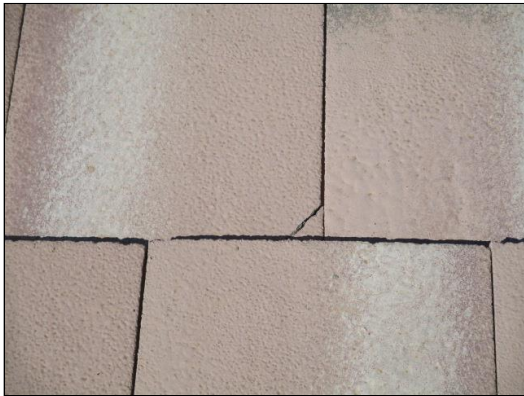
1.2 Item 1(Picture)

Cracked tile(s) present in various areas.
Further evaluation and repairs and/or replacement by a qualified service person suggested.

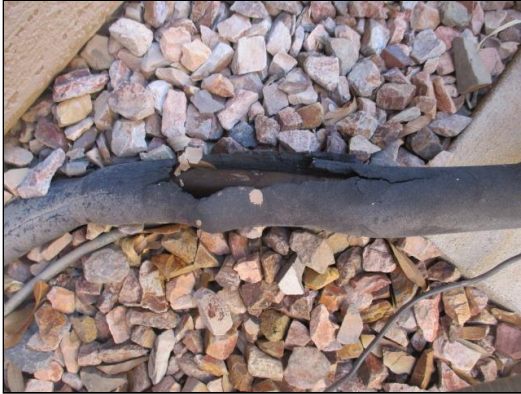
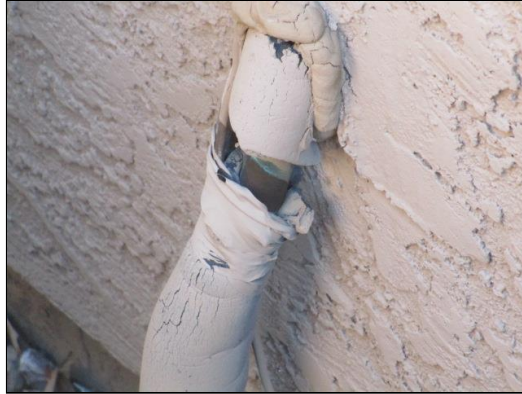
2.0.B Item 1(Picture)

(1) Insulation covering is sun baked/damaged on exterior unit refrigerant line. Insulation is used to retard heat gain and control condensation drip from cold-water plumbing, chilled-water, and refrigeration lines.

Adjustment(s) or correction/repair(s) are suggested.

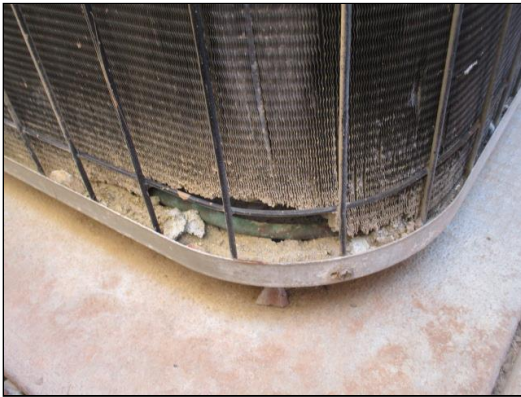
2.0.B Item 3(Picture)

(2) Fins are damaged at bottom of exterior unit.

Further evaluation and repairs and/or replacement by a qualified service person suggested.

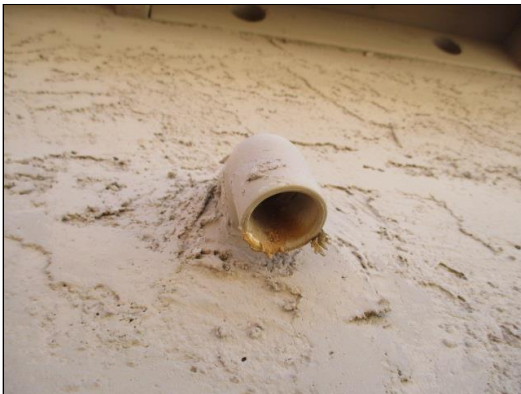
2.0.B Item 4(Picture)

(3) Rust present on exterior section of secondary condensate line.

Monitoring recommended: The inspected item or component will require regular monitoring to determine if its condition is degenerating or may degenerate to a point where it will no longer function in a satisfactory framework.

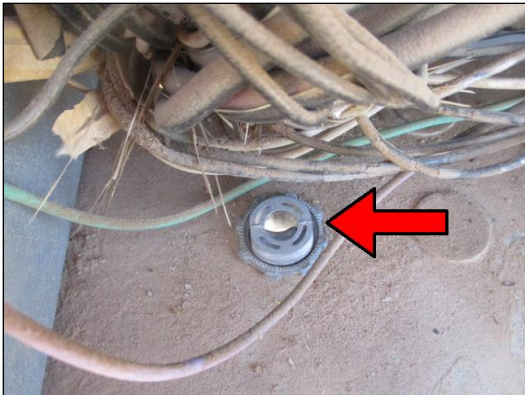
3.0 Item 1(Picture)

Open knock-outs present bottom of main panel. Installing blocker(s)/filler(s) advised.

Repairs are needed that can be performed by a knowledgeable handy person or competent homeowner.

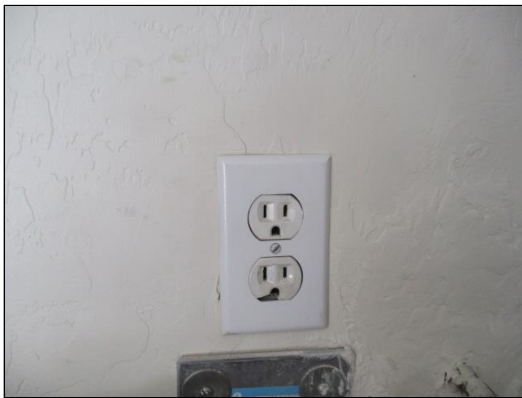
3.3 Item 4(Picture)

(3) N/E receptacle in garage damaged at bottom outlet.

Adjustment(s) or correction/repair(s) are suggested.

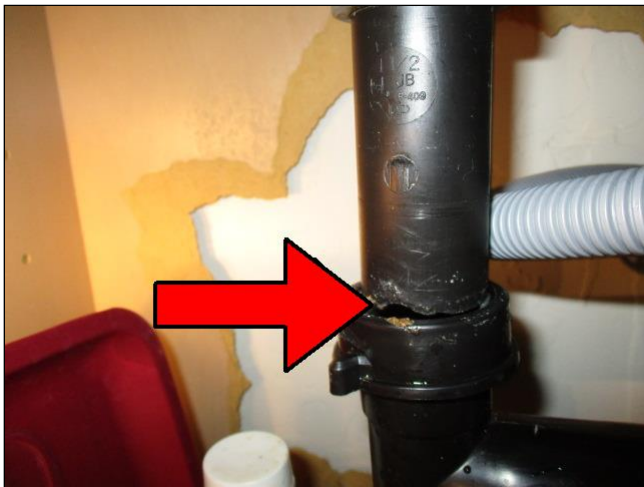
4.2 Item 1(Picture)

South drain leaked at kitchen sink (both basins filled half way then drained simultaneously).

Further evaluation and repairs and/or replacement by a qualified service person advised.

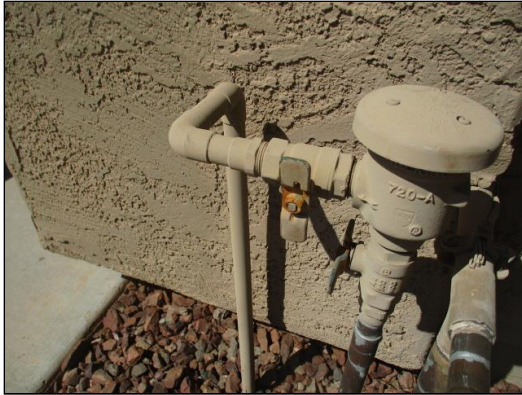
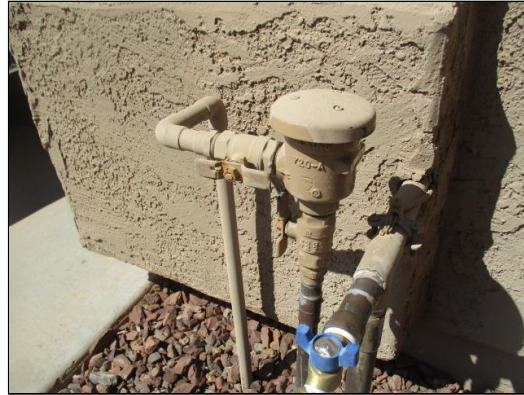
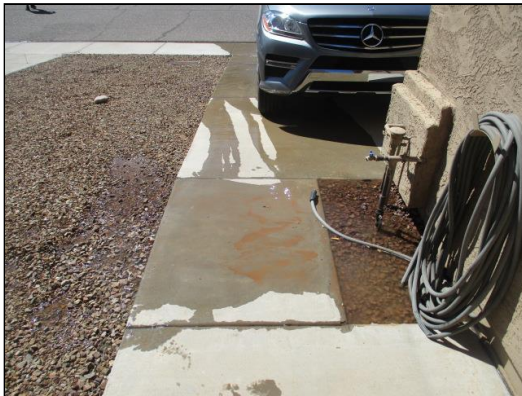
4.4 Item 1(Picture)

Irrigation system at South section appears to be disconnected and/or abandoned under soil, anti-siphon was shut-off. When turned on it flooded the S/E side.

Further evaluation and repairs and/or replacement by a qualified service person advised.

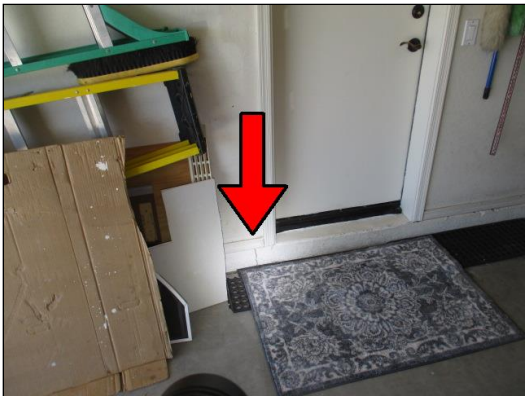
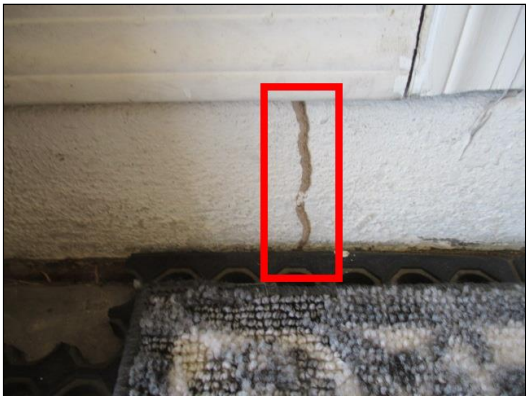
5.1 Item 1(Picture)

Subterranean termite shelter tubes observed.
Treatment and/or monitoring by a licensed professional advised.

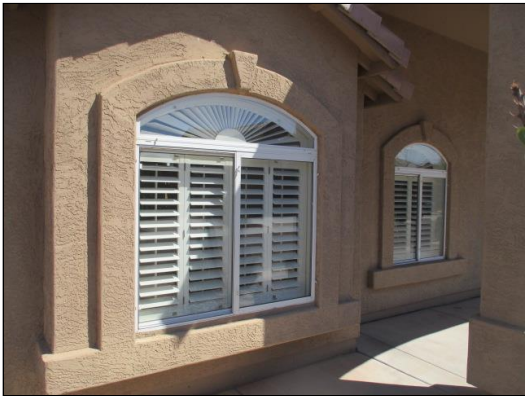
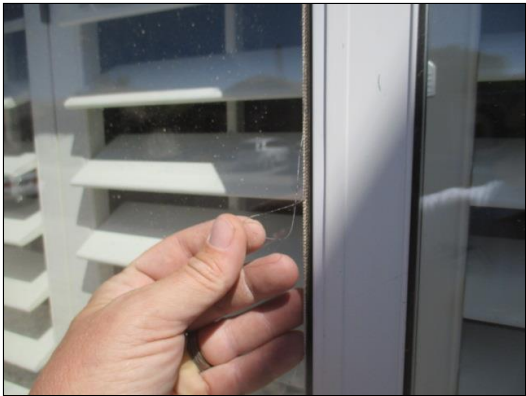
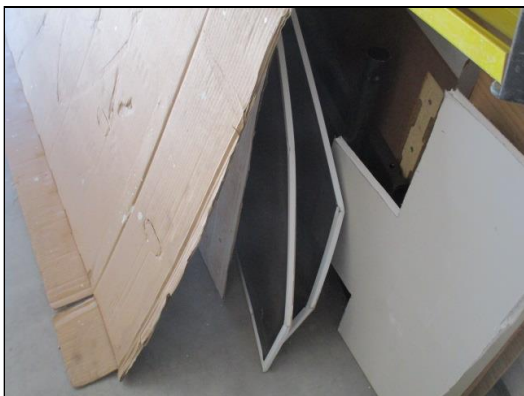
7.1 Item 1(Picture)

Screen(s) need repairs and/or maintenance (Some screens not installed noted in garage and South bedroom).

Repairs are needed that can be performed by a knowledgeable handy person or competent homeowner.

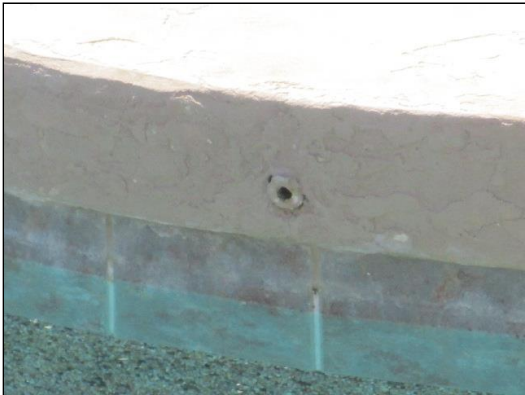
8.0 Item 1(Picture)

- 8.0
- Shell / Body / Cleaning devices / Decking / Aerator / Water features / Skimmers / Drains / Auto filling devices / Anti-siphon protection**
[Aerator nozzle missing/removed.](#)
[Adjustment\(s\) or correction/repair\(s\) are suggested.](#)

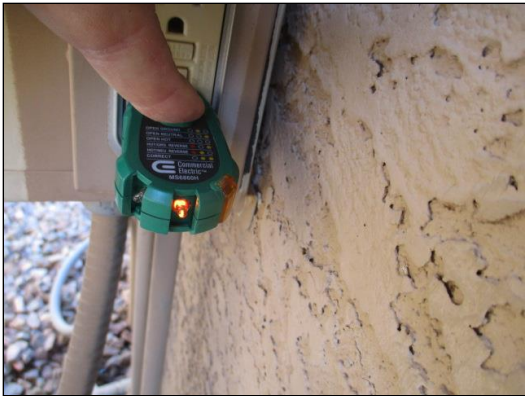
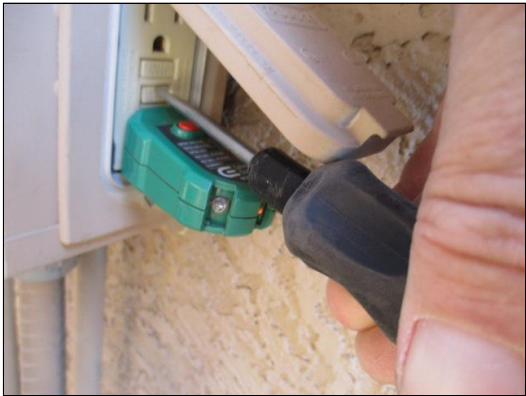
8.1 Item 1(Picture)

(1) GFCI receptacle protecting pool light did not trip during inspection.
Further evaluation and repairs and/or replacement by a qualified service person advised.

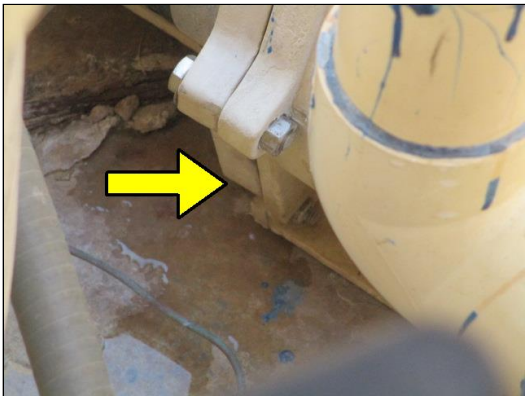
8.1 Item 3(Picture)

(2) Leak present at lower side of pump.
Further evaluation and repairs and/or replacement by a qualified service person suggested.

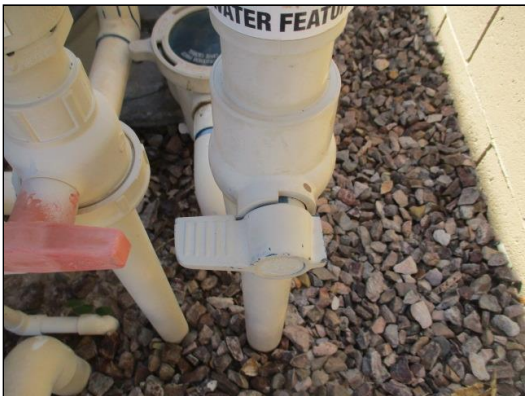
8.2 Item 1(Picture)

Water feature valve damaged.
Adjustment(s) or correction/repair(s) are suggested.

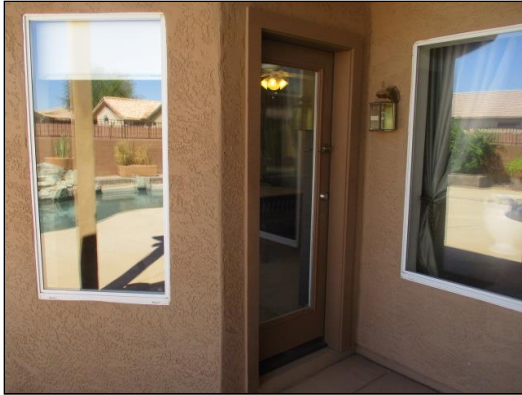
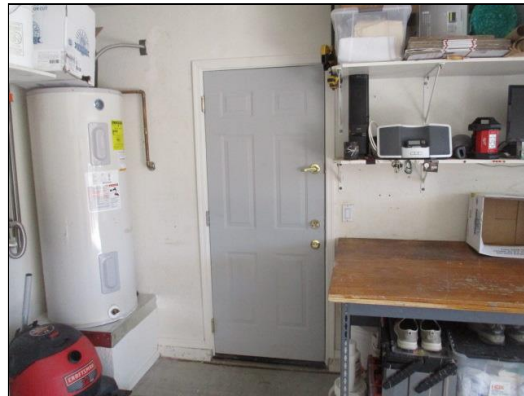
8.3 Item 1(Picture)

Pool barrier compliance breached. Back patio doors, pet door at West side of home and garage utility door.

Further evaluation and repairs and/or replacement by a qualified service person advised.

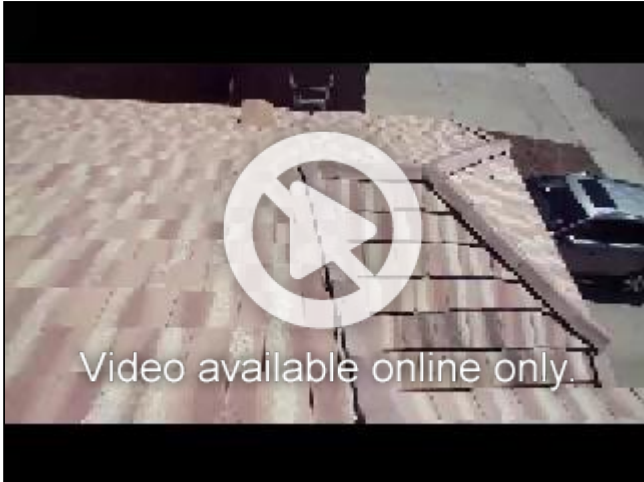
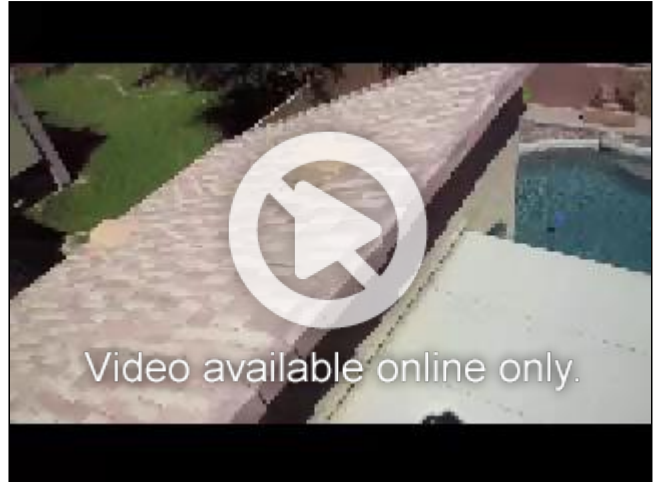
9.0 Item 1(Video)

(1) General Info: Video clips taken during roof inspection.

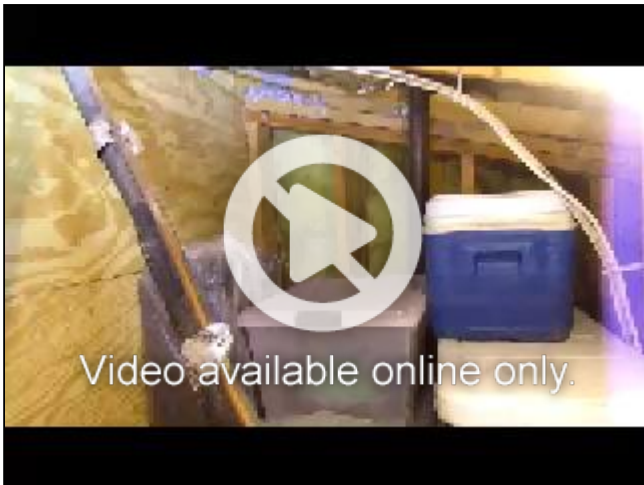
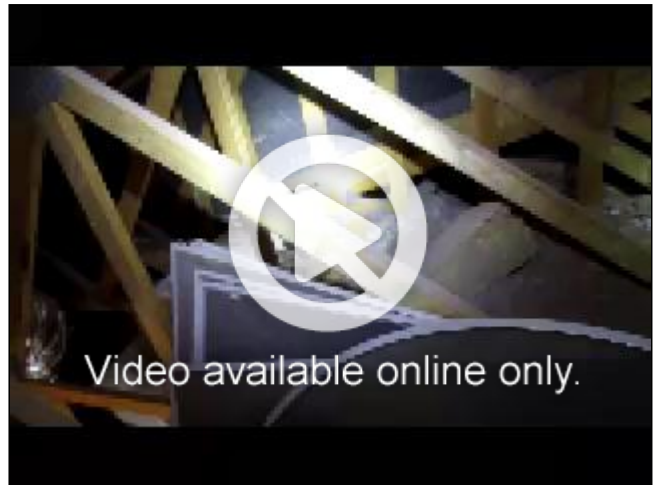
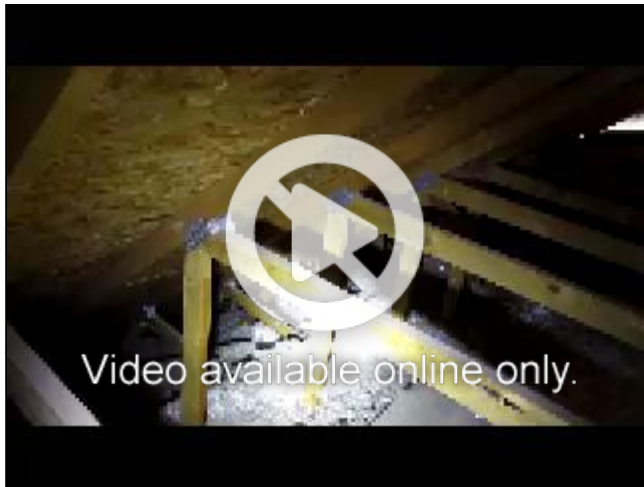
9.0 Item 3(Video)

(2) General Info: Video clips taken during attic inspection.
